**MISSION BAY PARK
2013 BATHYMETRY AND
EELGRASS INVENTORY**

2013 MISSION BAY PARK BATHYMETRY AND EELGRASS INVENTORY San Diego, California

2013 MISSION BAY PARK EELGRASS INVENTORY BATHYMETRIC CHART

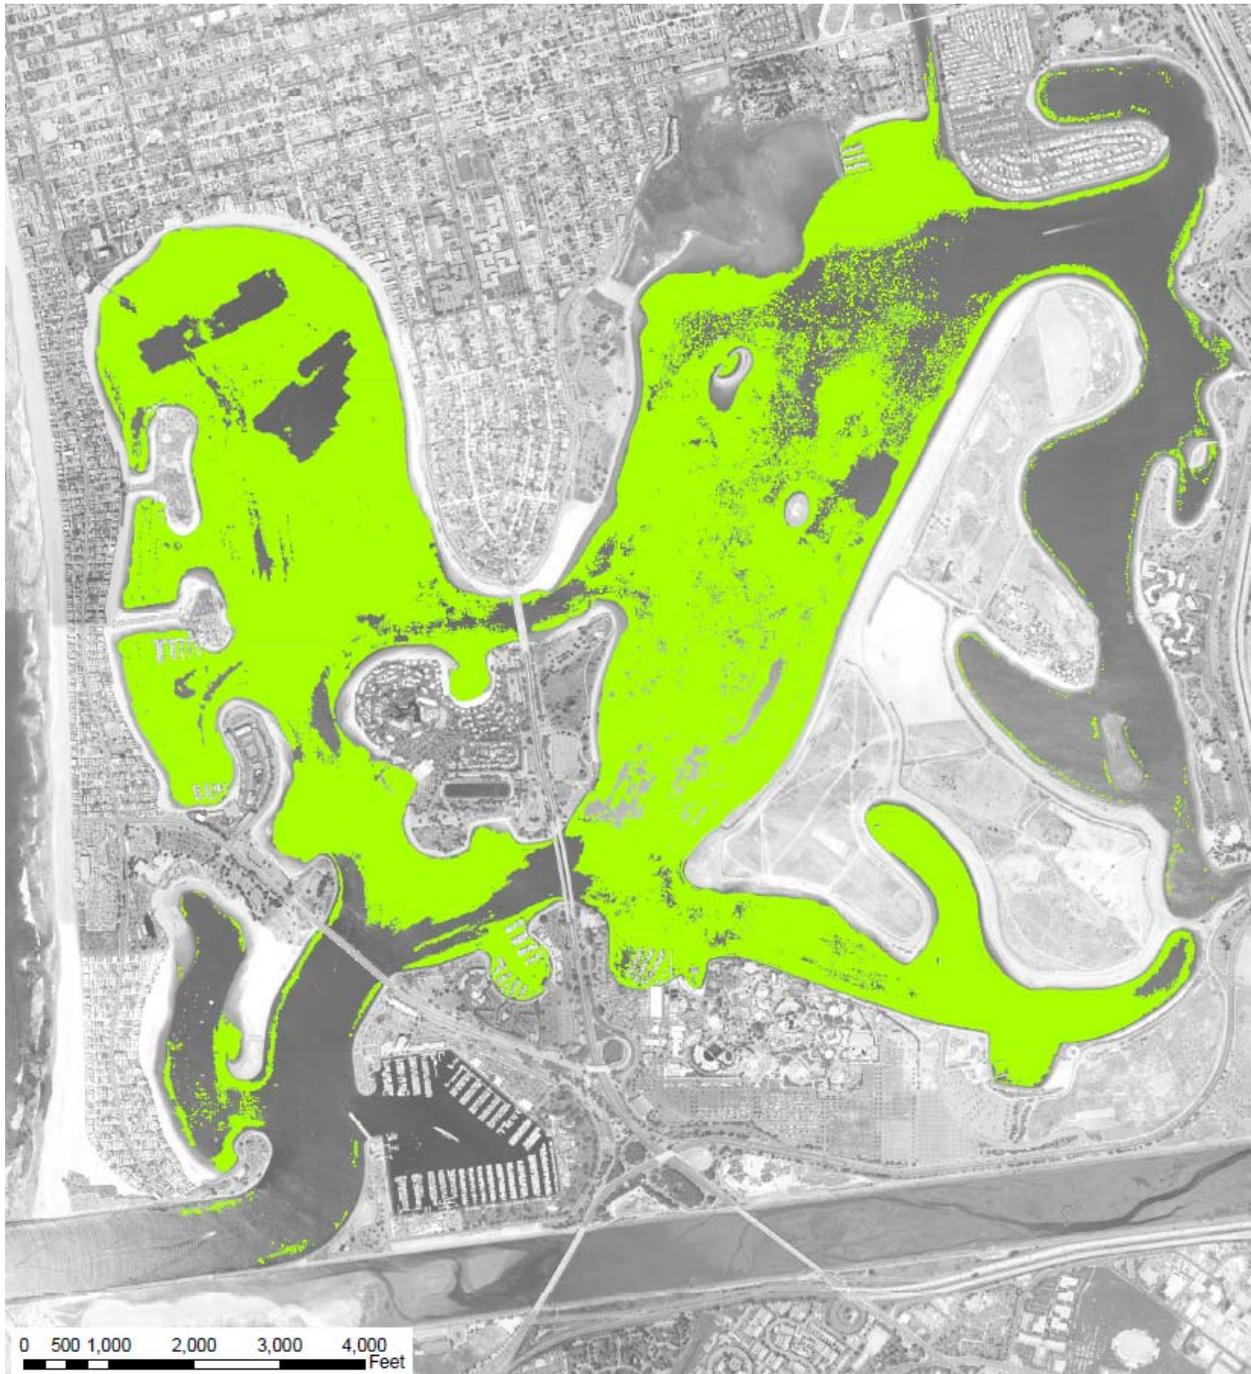
Figure 1. Eelgrass distribution patterns from summer 2013 surveys

There were 979.1 acres of eelgrass within Mission Bay at the time of the summer 2013 surveys (Figure 1). There are two species of eelgrass present in the Bay, common eelgrass (*Zostera marina*) and Pacific eelgrass (*Z. pacifica*), although they were not mapped separately. *Zostera marina* is the most common form of eelgrass within Mission Bay and likely accounts for about 99.7 percent of all eelgrass in the Bay, based on an estimated extent of *Zostera pacifica*. While *Z. marina* is found throughout the Bay, *Z. pacifica* is generally considered to be an open coastal species and is generally found in very sandy sediments at deeper depths and with elevated exposure to both

The extent of eelgrass is generally greatest within the better-flushed westerly portions of the bay, as illustrated in Figure 1, and in the attached map sheets (Appendix 1). Within the easterly portion of the bay, eelgrass is more extensive within more open waters such as Fiesta Bay that are subject to good tidal and wind driven circulation.

Eelgrass grows to a maximum verifiable depth of over 20 feet within Mission Bay. This occurs within patches of Pacific eelgrass (*Zostera pacifica*) located in the Mission Bay Entrance Channel. However, 99.9 percent of all of the Mission Bay eelgrass occurs within depths of less than 17 feet MLLW, and 99 percent of the eelgrass in Mission Bay occurs between 0 and 14.5 feet MLLW with all of the deeper eelgrass occurring within the southwestern entrance area of the Bay.

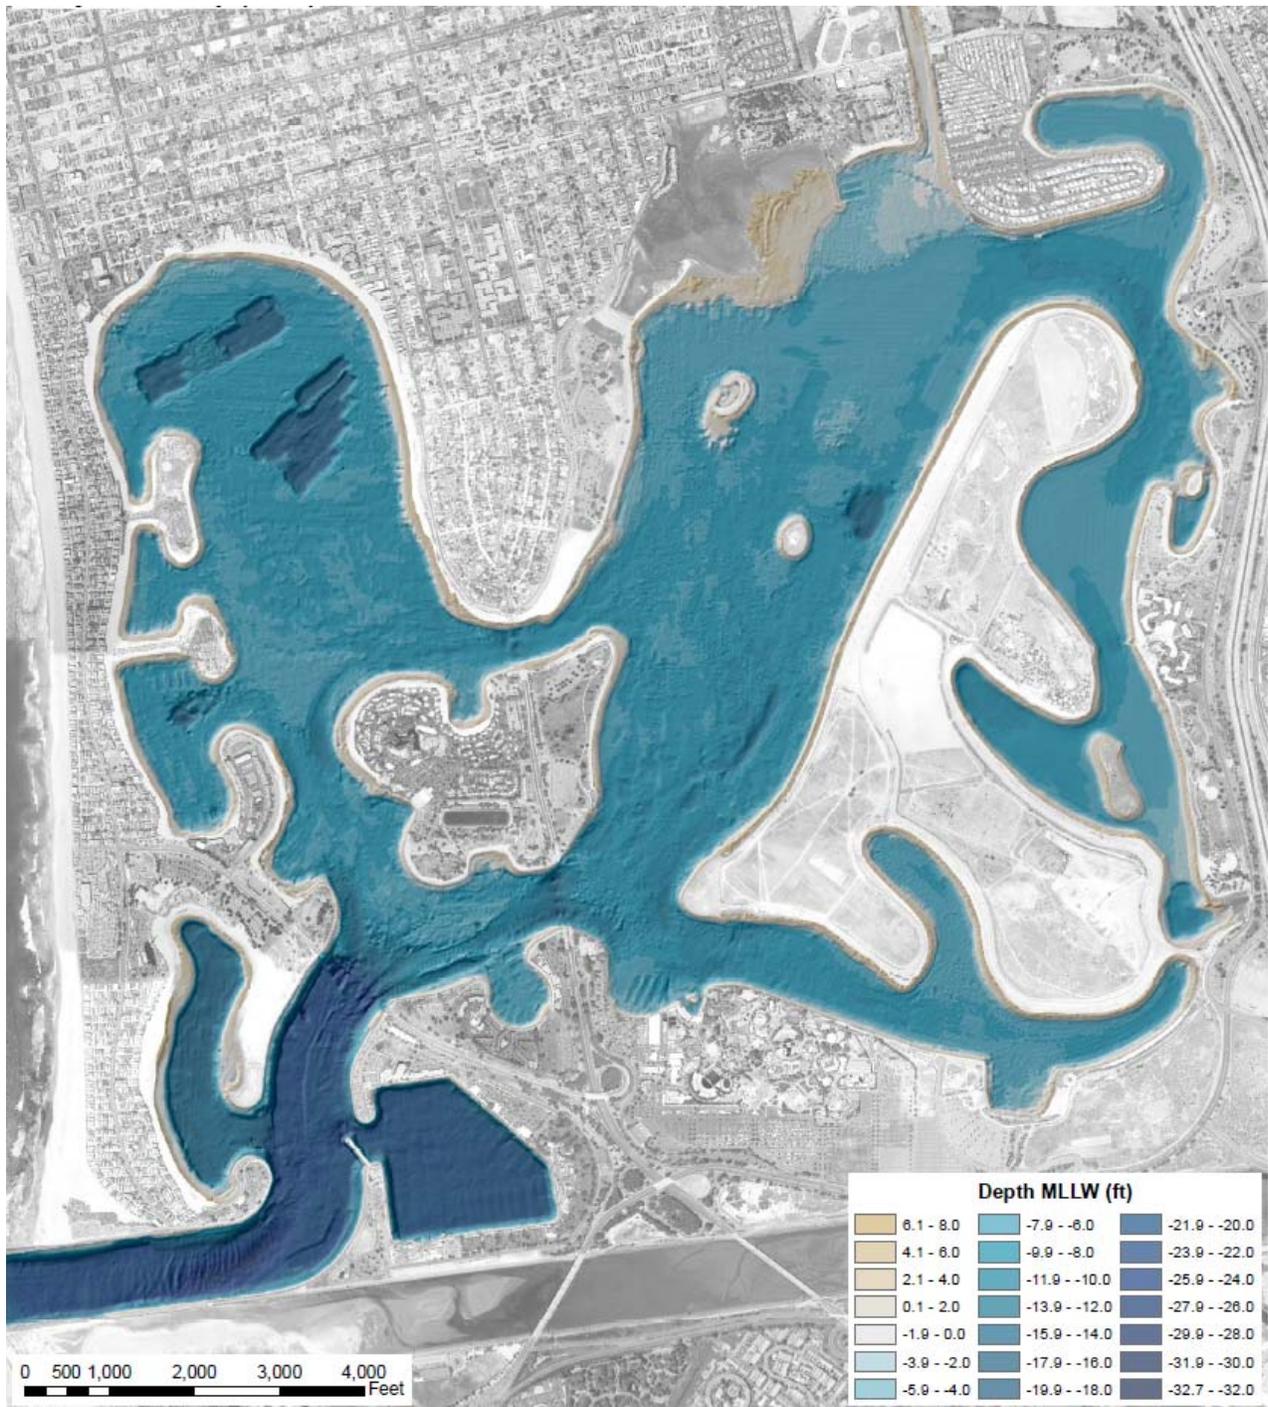
Figure 2. 2013 Mission Bay Bathymetry.

Bathymetry of Mission Bay is that of a developed recreational embayment. The 2013 bathymetry of Mission Bay is illustrated in Figure 2 and on the individual chart sheets of Appendix 1. Depths range from intertidal to -30 feet within scour pits at the West Mission Bay Drive Bridge. In general, the Bay has a relatively flat bottom driven by initial design to accommodate shallow to mid-draft recreational vessels. Approximately 60 percent of the Bay occurs between the depths of -12 and -6 feet MLLW. An additional 17 percent of the Bay occurs below -12 feet MLLW. Approximately 9 percent of the Bay area occurs between -6 and -2 feet MLLW. Above -2 feet, intertidal areas total 14 percent of the bay area comprising intertidal beaches, mudflats, and marshes, as well as reveted shoreline.

The distribution of deeper and shallower water typically follows a west to east progression with the Mission Bay Entrance Channel, Quivira Basin, and Mariner's Basin being predominantly deep environments with waters principally being between -15 to -20 feet in depth. From the West Mission Bay Drive Bridge to the east, waters step up to shallower depths generally ranging from -8 to -10 feet. Within this general bathymetric condition, there are several mid-bay borrow sites, and scour holes within areas of concentrated tidal flow that have resulted in greater depths. There are also areas of shallower shoaling, typically associated with areas of scour erosion, and areas of sediment delta formation that are attributable to watershed fluvial inputs.

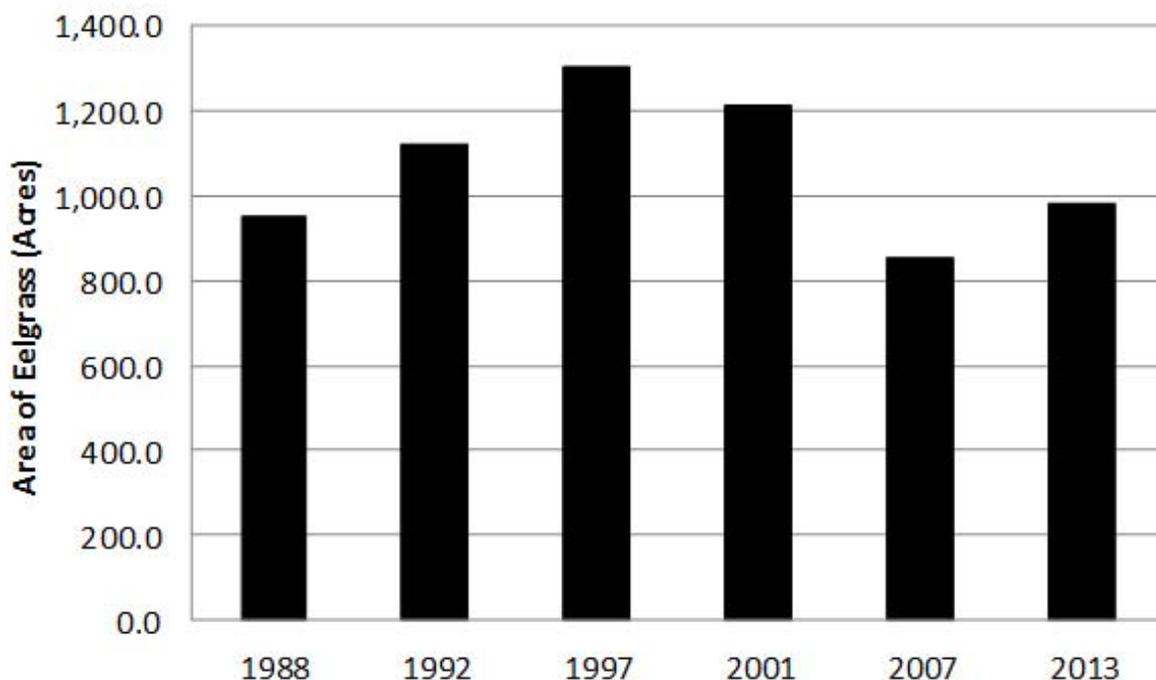
Figure 3. Eelgrass cover changes in between 1988, 1992, 1997, 2001, 2007 and 2013 surveys

A comparison of eelgrass coverage and distribution patterns between the 1988, 1992, 1997, 2001, 2007 and the present 2013 surveys indicate an overall eelgrass expansion trend between 1988 (949.3 acres) and 1997 (1,306.6 acres). From 1997 to the 2007 survey, eelgrass fell to the lowest area mapped in the 25-year comprehensive survey record (Figure 3). In 2007, eelgrass covered only 856.0 acres (37%) of the bay bottom. This is only 65.5% of the eelgrass coverage mapped in 2001. During the present 2013 survey, eelgrass rebounded by 123 acres from the 2007 low (Figure 2).

At the present time, eelgrass occupies approximately 43 percent of the Bay, up from the prior 2007 survey period (Table 1). The eelgrass geographic distribution on a macro-scale has not changed significantly from 2007 to 2013; however it should be noted that the most significant declines from 2001 forward have been in the eastern portions of the Bay within De Anza Cove and North Pacific Passage. This is reflected best in the observed eelgrass area decline in Appendix 1 map sheets 1, 4, and 7. Other significant declines that were observed between the 2001 survey and the 2007 survey have substantially recovered. Notably, losses of eelgrass between 2001 and 2007 occurred in the middle and higher density beds of Sail Bay and portions of central Fiesta Bay (Table 1). The 2001 to 2007 losses within these core beds are not as obvious in the summary graph presented as Figure 2. However, by 2013, much of the large losses in the large basin areas had recovered.

During the prior 2007 survey, it was noted that the significant eelgrass decline within Mission Bay from 2001 to 2007 (Figure 3) exhibited characteristics suggestive of a biological agent rather than a physical stressor. This was based on the fact that the principal eelgrass losses were detected in the core eelgrass beds rather than at the upper or lower margins where desiccation and light limitation, respectively, typically restrict eelgrass distribution. Further, losses were greatest within areas that have historically been persistent and which have supported the highest density eelgrass.

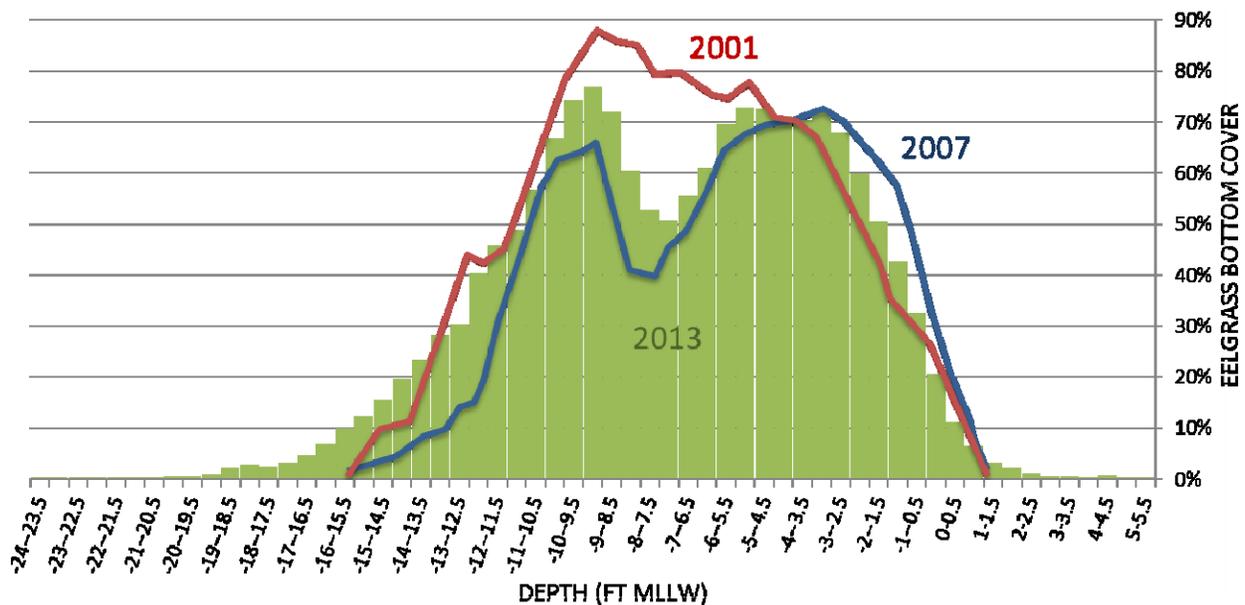
Figure 4. Eelgrass depth distribution as a percentage of available area in half-foot depth bins.

Using the bathymetric data collected during the 2007 survey period analyses were completed to evaluate the depth distribution for eelgrass within Mission Bay during 2007. This was completed again in 2013 (Figure 4). These eelgrass depth distributions were compared to the eelgrass depth distribution found in 2001. The data reveal a substantial decline in eelgrass presence within the central portion of the 2001 distribution range occurred in 2007. The decline is so striking as to generate a bimodal depth distribution curve where a unimodal curve would normally be expected. This bimodal distribution curve was further evidence of a third significant controlling factor affecting eelgrass in 2007. This overall depth distribution pattern coupled with the specific spatial patterns of decline strongly suggested a biological control agent was operative, however no direct observational evidence of a pathogen was found at that time. The bimodal depth distribution observed in 2007 continued in 2013 although substantial recovery of eelgrass in the Sail Bay and Fiesta Bay areas has occurred, leaving most of the reduction in eelgrass coverage within the far eastern portions of the Bay, where lower water quality may play a role in reduced recovery rates.

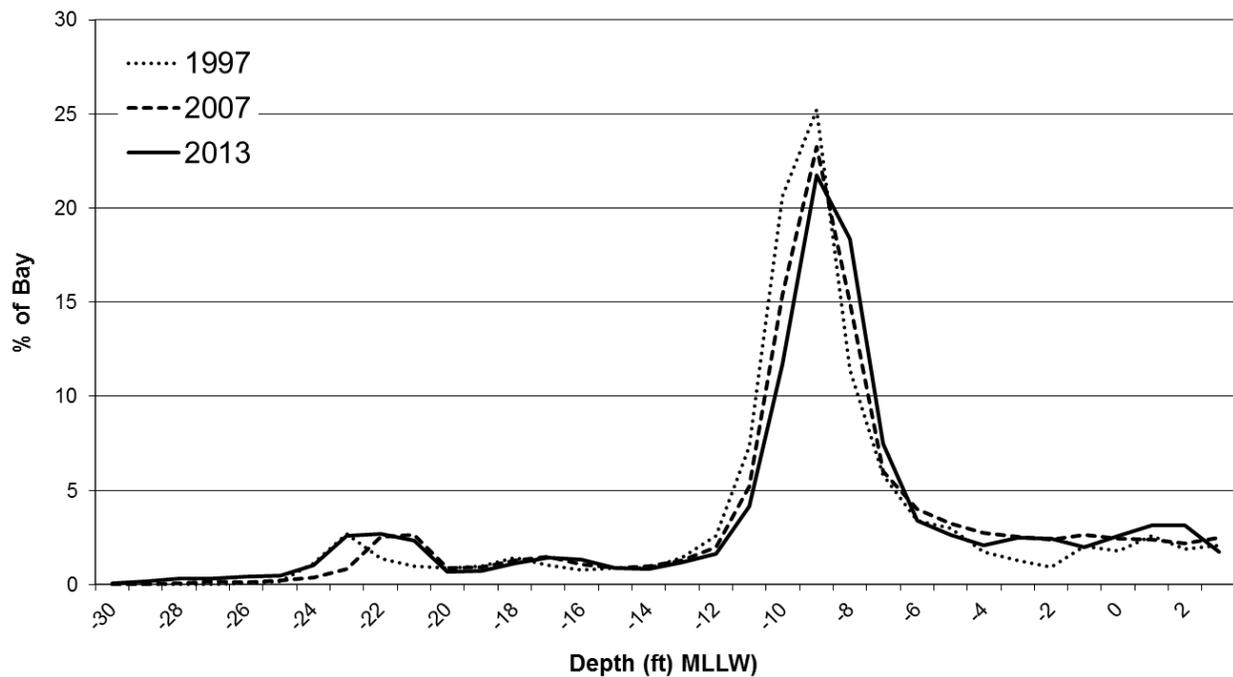
Figure 6. Change in Mission Bay depth distribution as a percentage of the total bay.

The 2013 bathymetry of Mission Bay is illustrated in the individual map sheets that follow as Appendix 1. An analysis was performed to compare proportional bay depth distribution between the prior 1997 and 2007 surveys and the present 2013 bathymetric mapping Figure 6. Overall, this analysis indicated various minor shifts in bay depths over the past sixteen years. When reviewed in more specific detail, the changes are principally driven by a handful of locations where moderate to major sedimentation has been ongoing. The most visible regions of deposition include Quivira Basin, near the outlets of Rose Creek and Tecolote Creek. Areas of less substantive accretion are noted within the farthest reaches of the bay in both the North and South Pacific Passages, in and around Leisure Lagoon, on the southwest corner of Vacation Island, and between the entrance of Santa Barbara Cove and the northwest corner of Vacation Island.

The bathymetric analysis reveals far less erosion that appears to be confined to small segments of the Mission Bay channel south of Vacation Island, north of Vacation Island in the Fisherman’s Channel between Sail Bay and Fiesta Bay, and immediately inside the entrance of Santa Barbara Cove. There are some notable increases in the percent of bay area at depths in the -20+ to -24 foot MLLW range and a parallel reduction in the extent of bay area in shallower areas. This deepening is the result of federal channel and basin maintenance dredging conducted by the Army Corps of Engineers between the 2007 and 2013 surveys.

The comparison of bathymetric conditions over the sixteen years (1997-2013) reveals little large scale change in the bathymetry of Mission Bay and no surprising areas of sediment accumulation given the bay hydrodynamics and sediment sources. Areas where more substantive changes in bathymetry have occurred include the deeper basins and areas near fluvial inputs. Throughout Quivira Basin there has been 1-2 ft. of deposition from 1997 to 2007 depending upon the area of the basin. In the North and South Pacific Passages, limited water flow and sediment input from Tecolote Creek (North Passage only) has resulted in deposition on the order of 0.5-1.5 ft. over the decade between 1997 and 2007 and relatively little additional change through 2013. Shoaling in the main channel has increased between 2007 and 2013, some of this change likely stems from the channel dredging by the Corps that would have both enhanced water movement in the channel and loosened sands, creating greater capacity for secondary mobility of the material into areas near southwest Vacation Island and along both the southerly and westerly sides of Vacation Island.
